Pre Mitigation Impact Assessment

Inspection Performed For:
Commercial Medical Center

Inspection Performed At:
411 South Medical Ave
Any City, Florida 33333

Inspection Performed On:
April 30, 2024

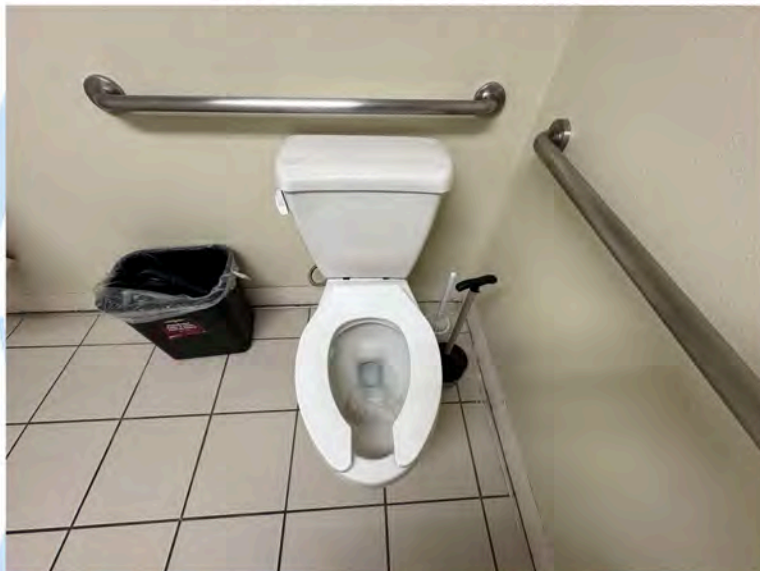
Cause of Loss Picture

Source: Toilet Malfunction causing an overflow

Loss Narrative: The toilets overflowed in the Women's Bathroom.

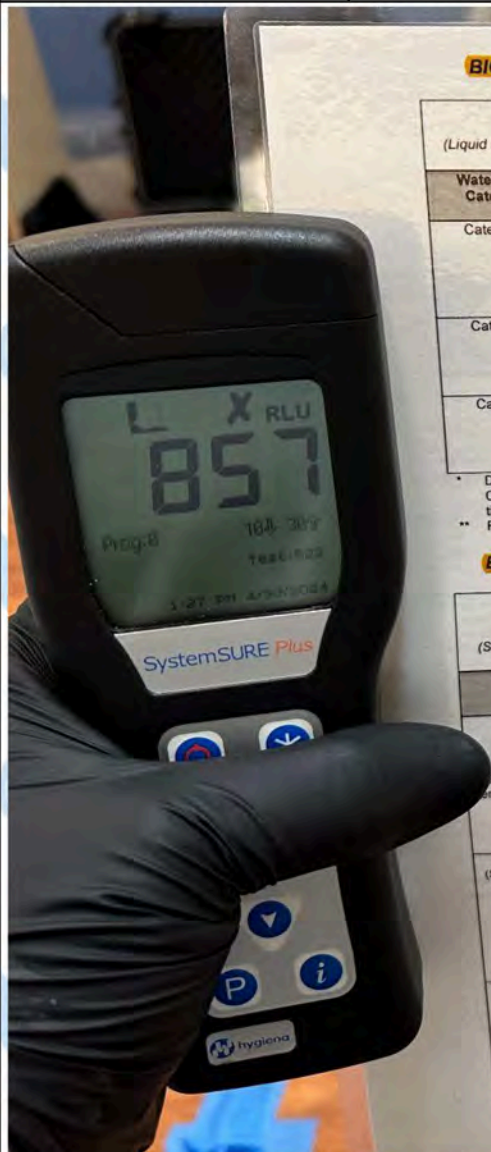
Description	Location	Type
Enviro Reveal	Main Hallway 1	Pre Mitigation #857

II. Bacterial Sampling: Higher Than Recommended

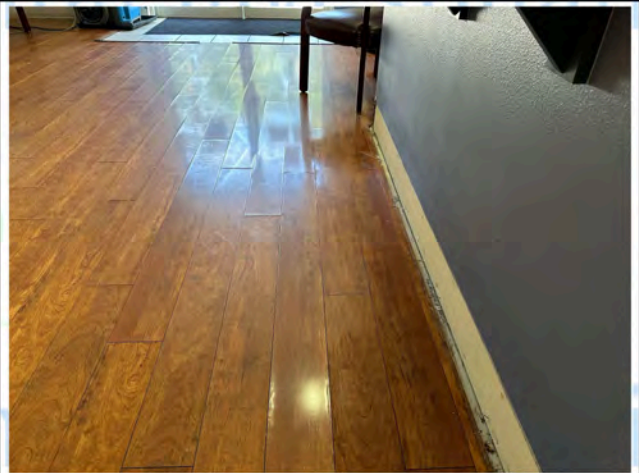
Waiting Room - Visible Water Damage

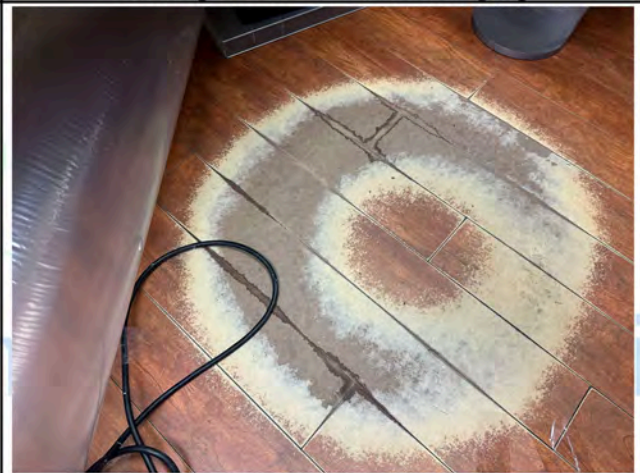
Main Office - Visible Water Damage

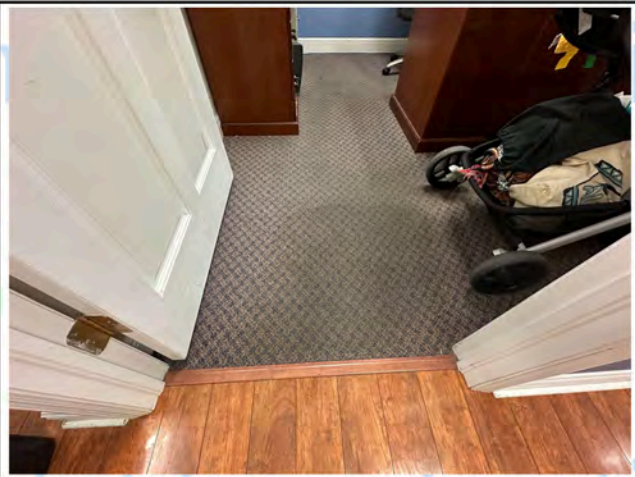
Manager's Office - Visible Water Damage

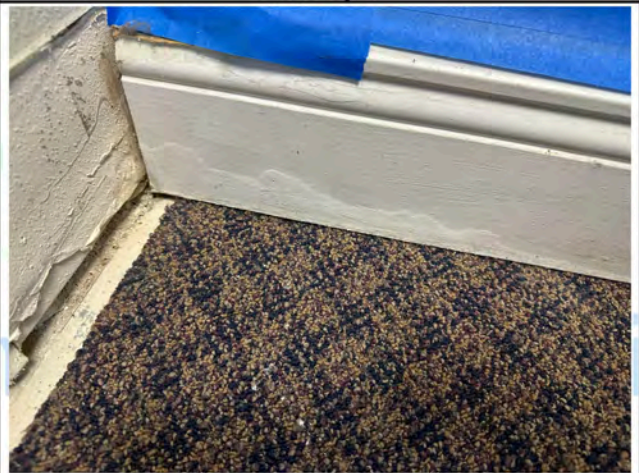
Room 1 - Visible Water Damage
