Pre Mitigation Impact Assessment

(According to IICRC S500 Section 10.6.7)

123 Any Street
Any Town, FL 33333

January 1, 2024

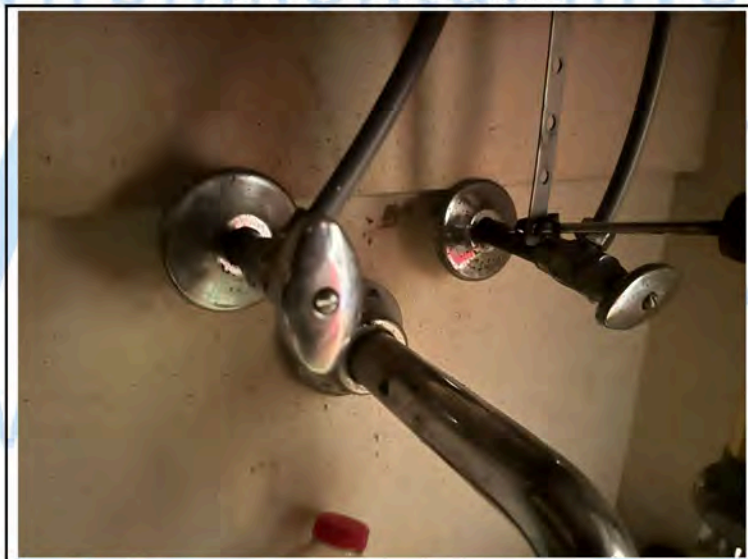
Cause of Loss Picture

Source: Valve Leak In Vanity

Room: Bathroom

Loss Narrative: The homeowner went downstairs to find standing water all over the floor.

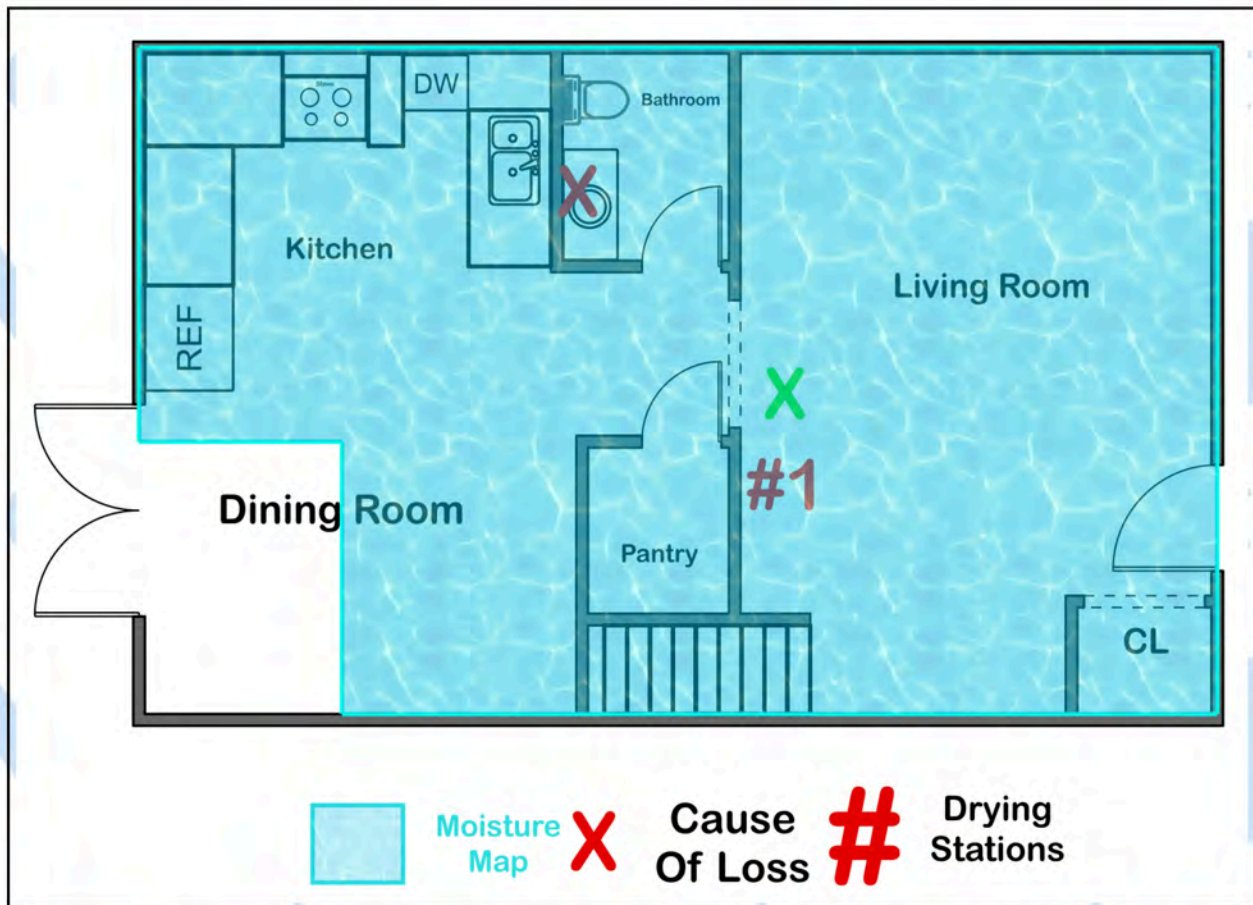
III. Moisture Mapping & Drying Stations

Drying Station	Flooring MC	Sill Plate/Stud MC	Concrete MC
Bathroom	100%	40%	40%(Vanity)
Dining Room	80%	40%	15.5%(Drywall)
Kitchen	100%	None Detected	36.3%(Cabinetry)
Living Room	100%	40%	23.5%(Drywall)

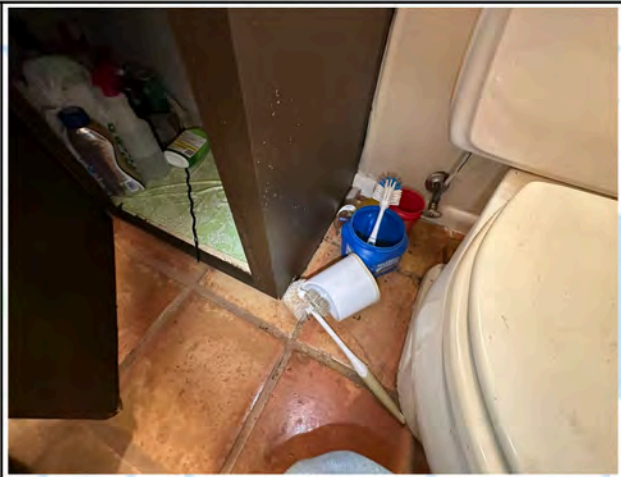
Bathroom Visible Water Damage

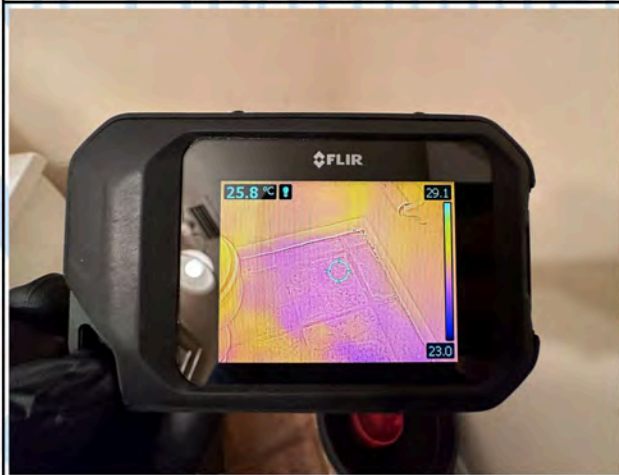
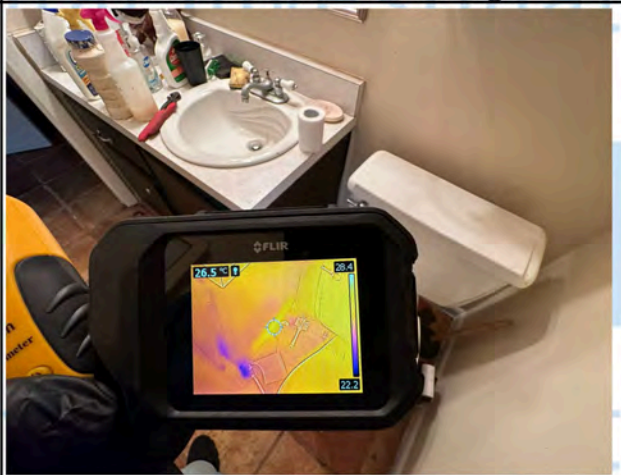
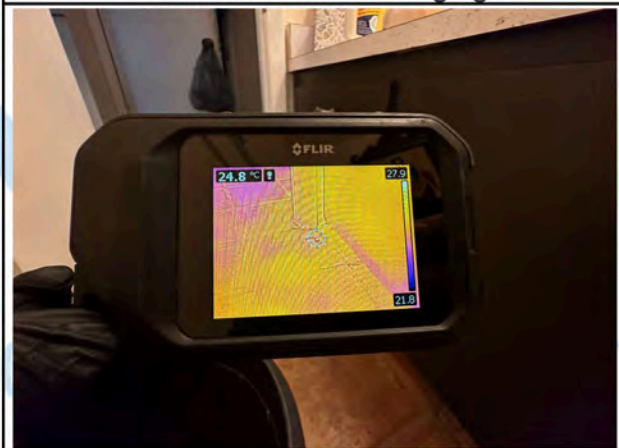
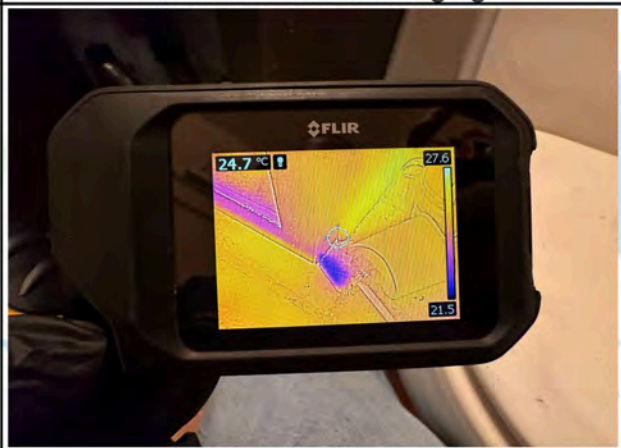
Bathroom Thermal Imaging

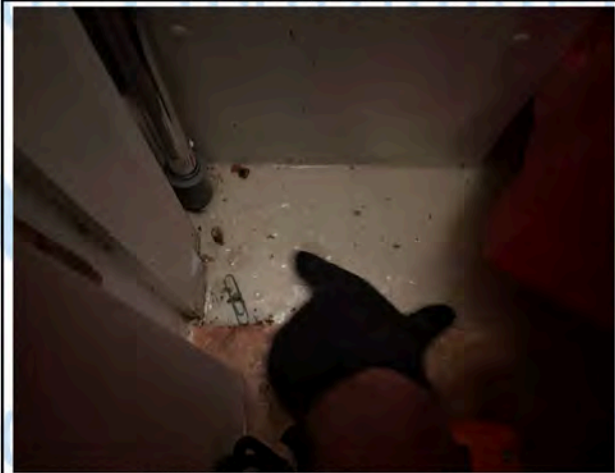
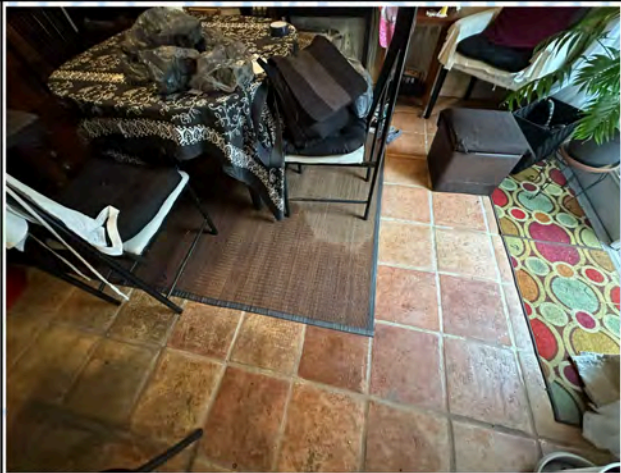
Dining Room Standing Water

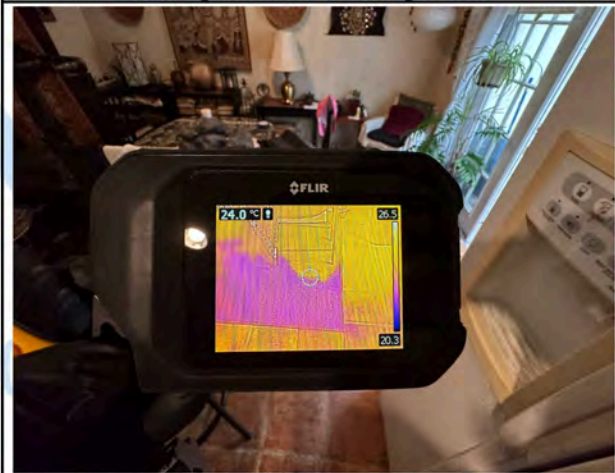
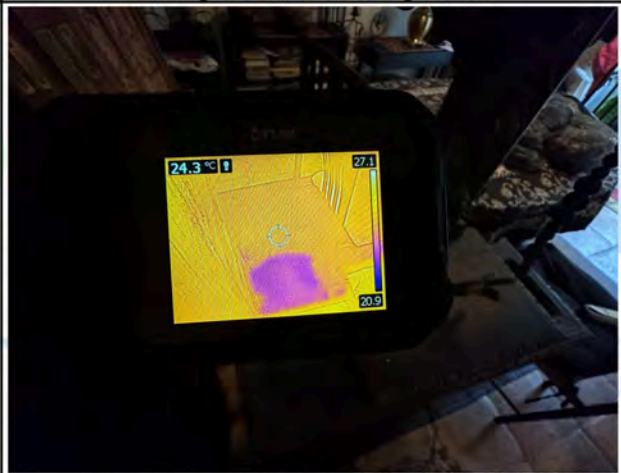
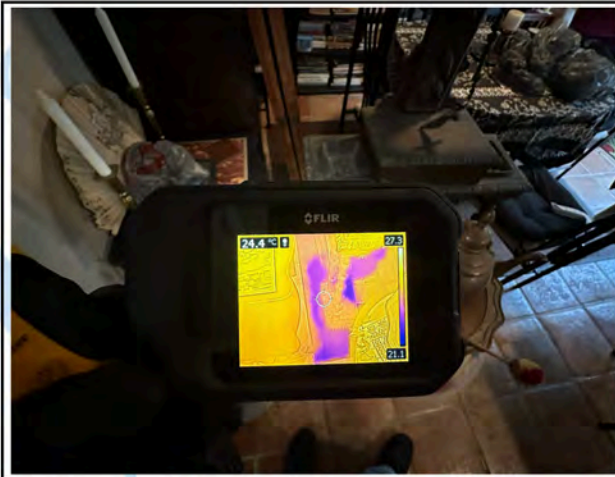
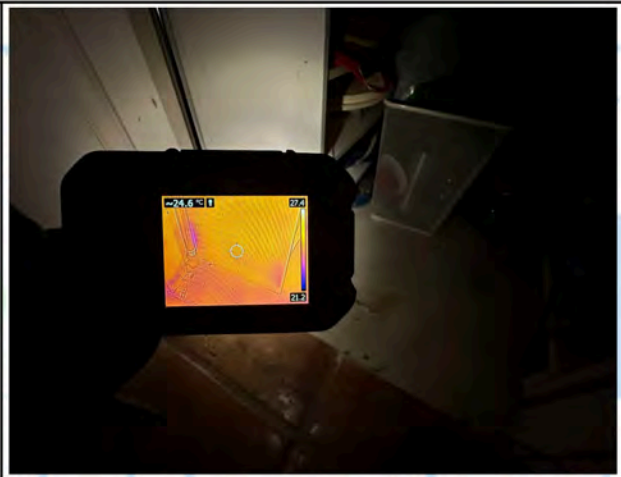
Dining Room Thermal Imaging

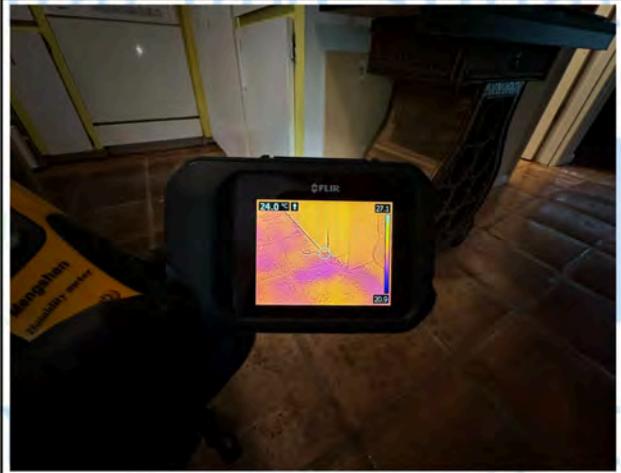
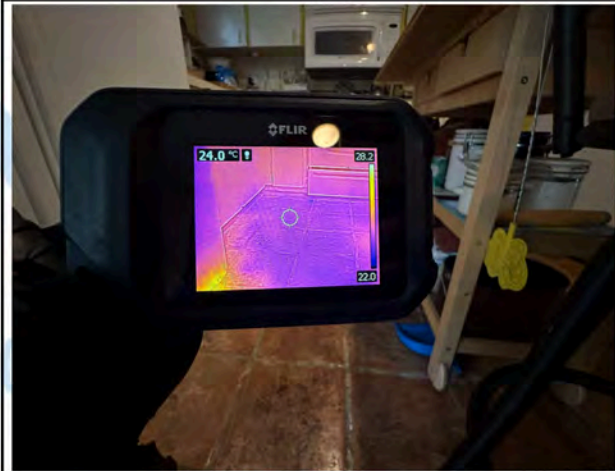
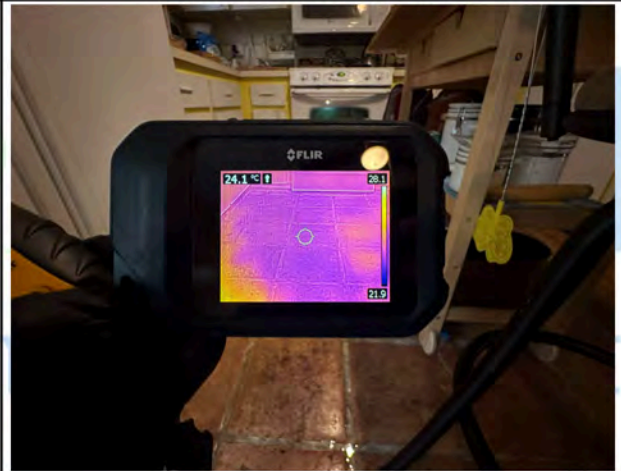
Kitchen Thermal Imaging

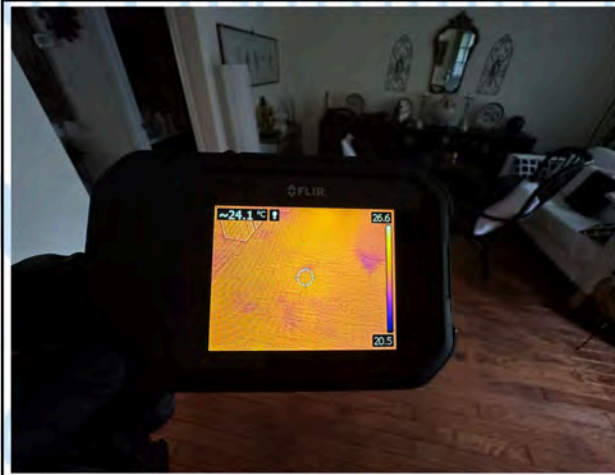
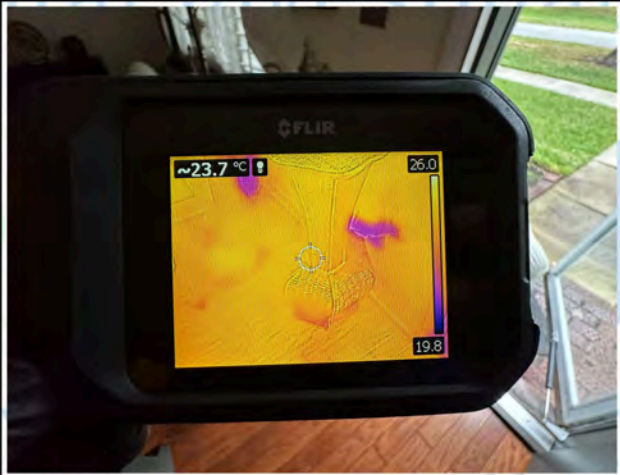
Living Room Thermal Imaging
