Pre Mitigation Impact Assessment

Inspection Performed For:
Commercial Medical Center

Inspection Performed At:
411 South Medical Ave
Any City, Florida 33333

Inspection Performed On:
April 30, 2024

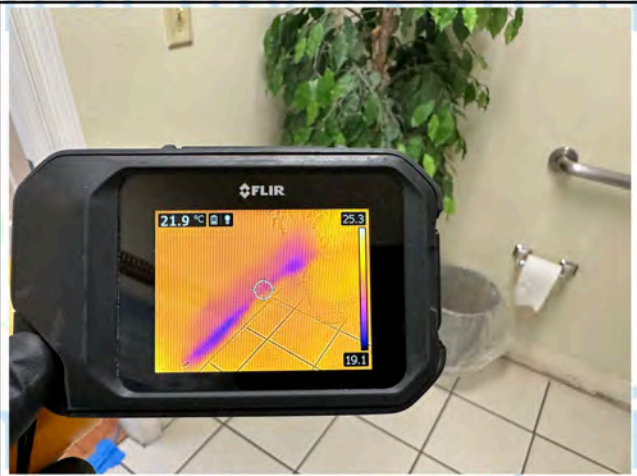
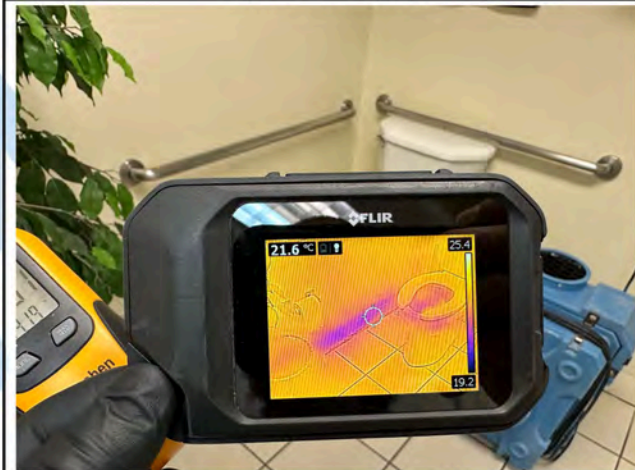
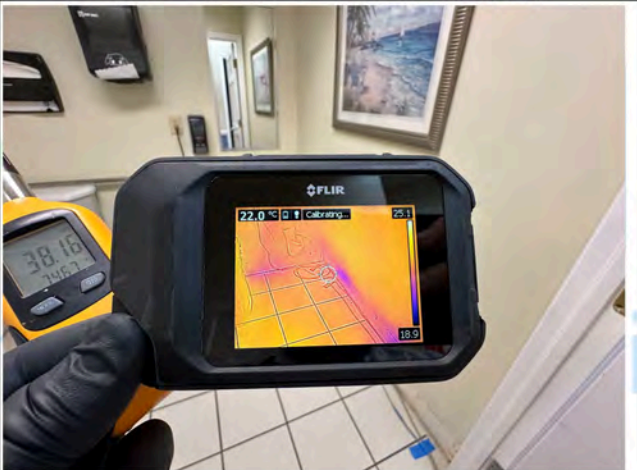
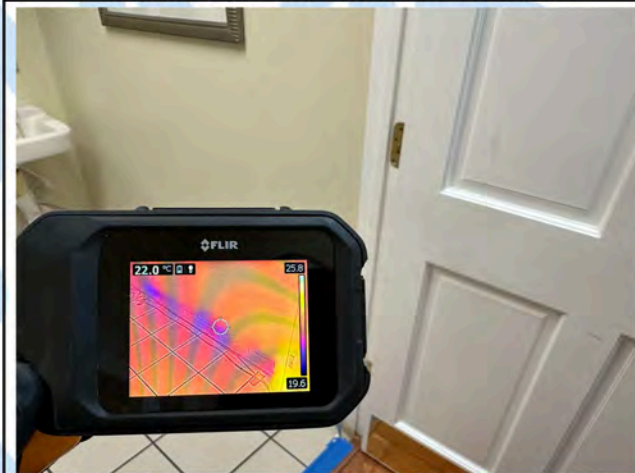
Men's Bathroom - Thermal Imaging

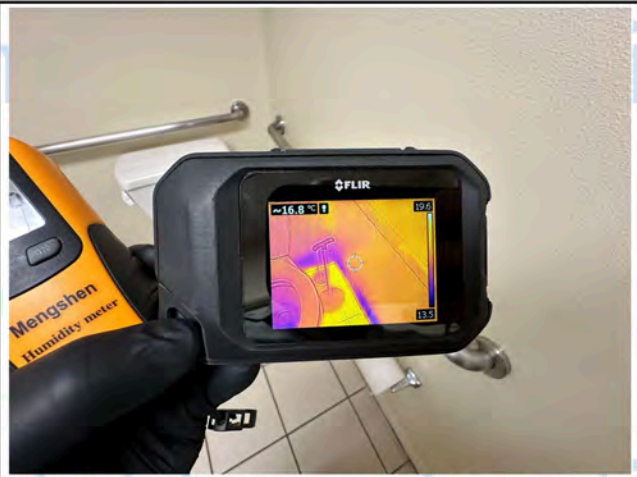
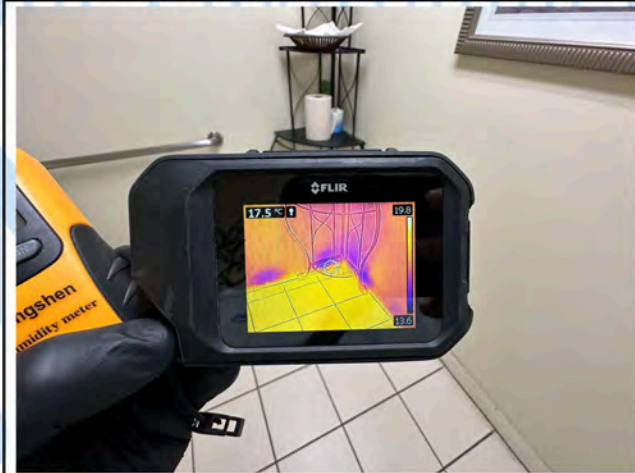
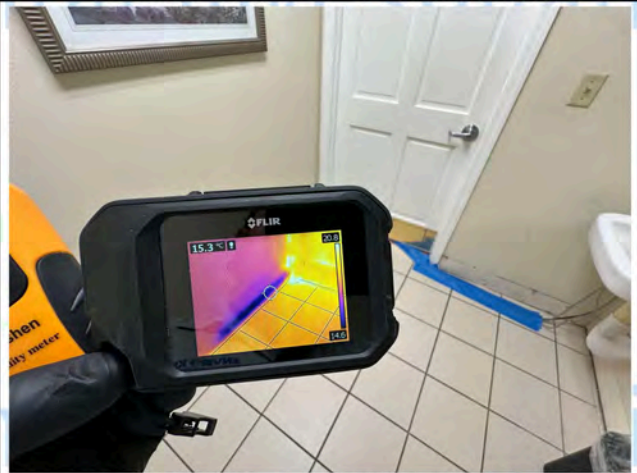
Women's Bathroom - Thermal Imaging

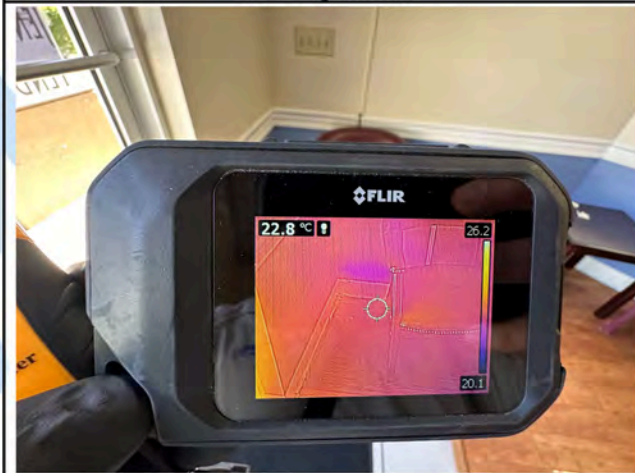
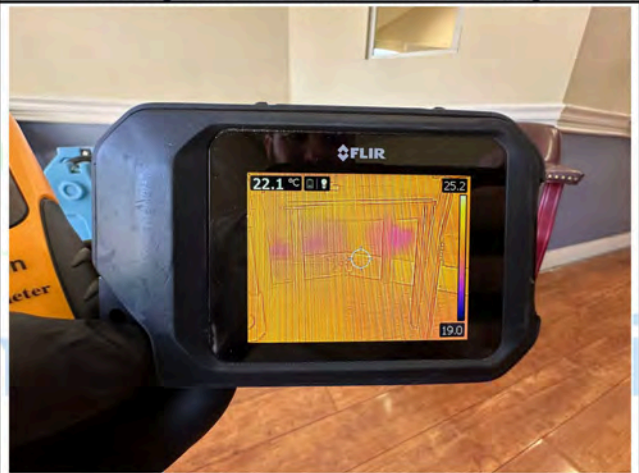
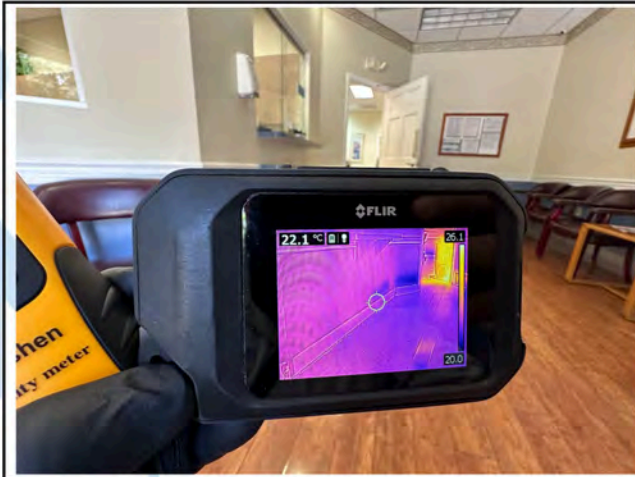
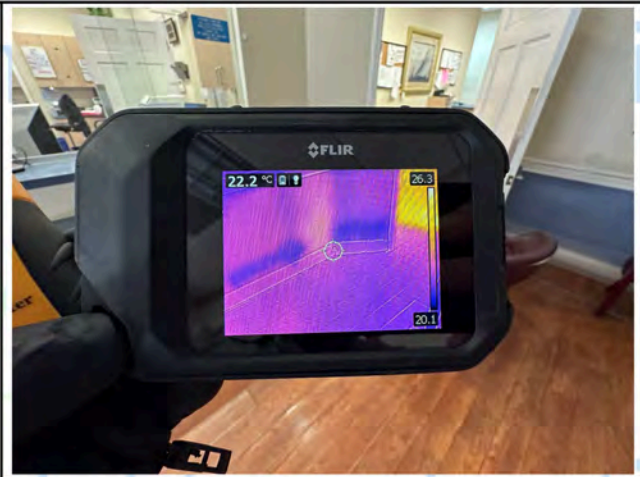
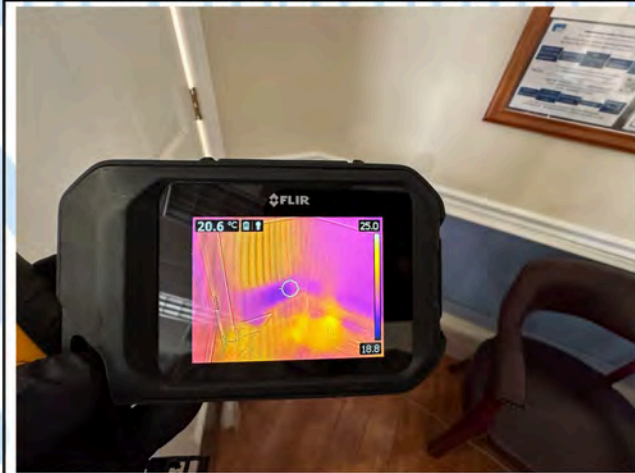
Waiting Room - Thermal Imaging

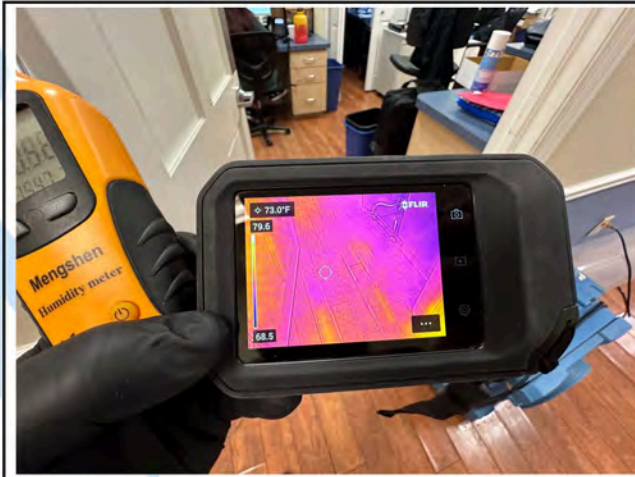
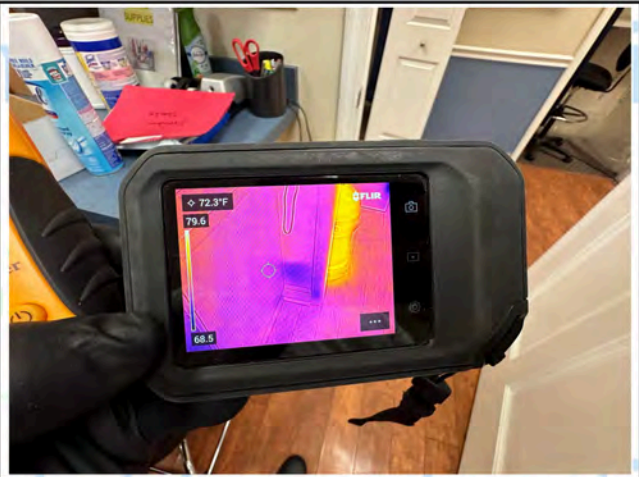
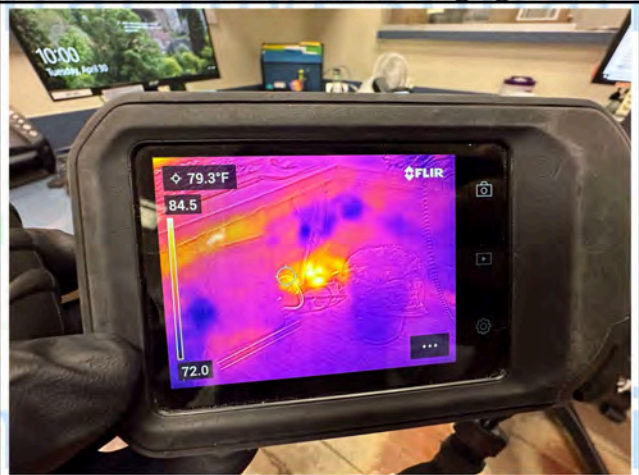
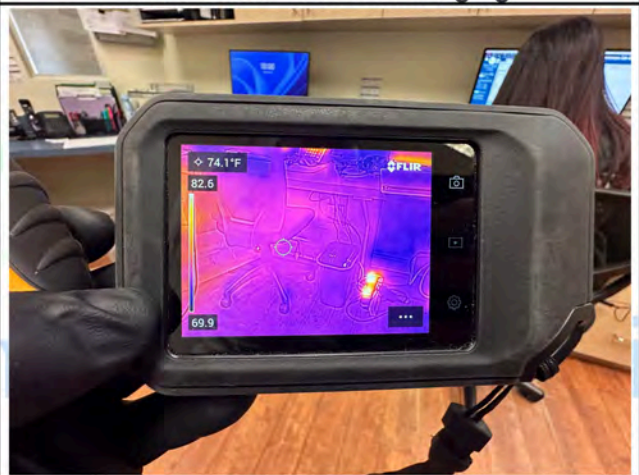
Main Office - Thermal Imaging

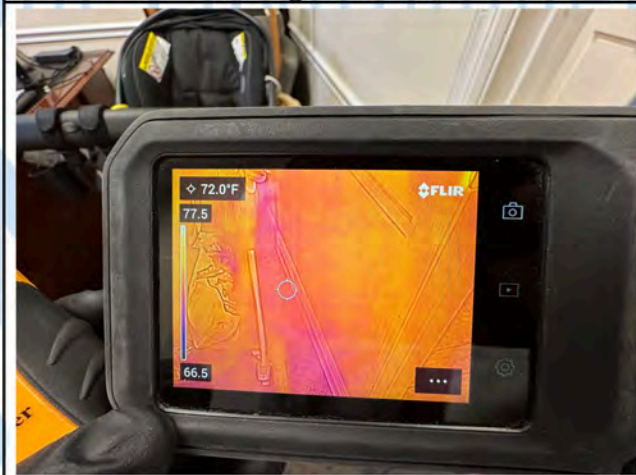
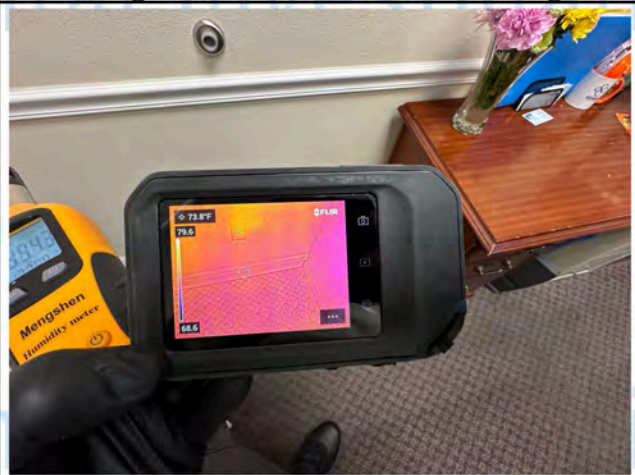
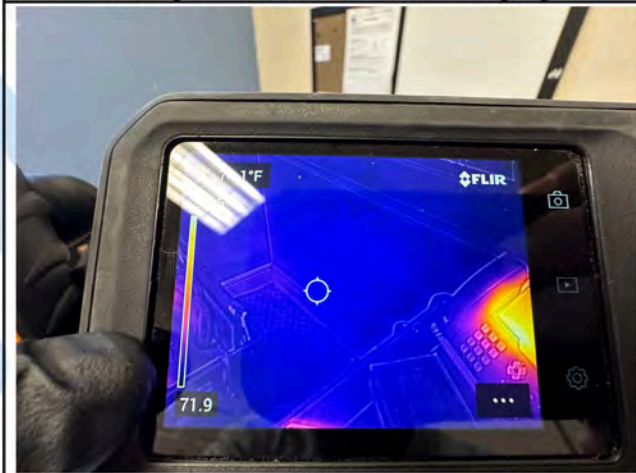
Manager's Office - Thermal Imaging

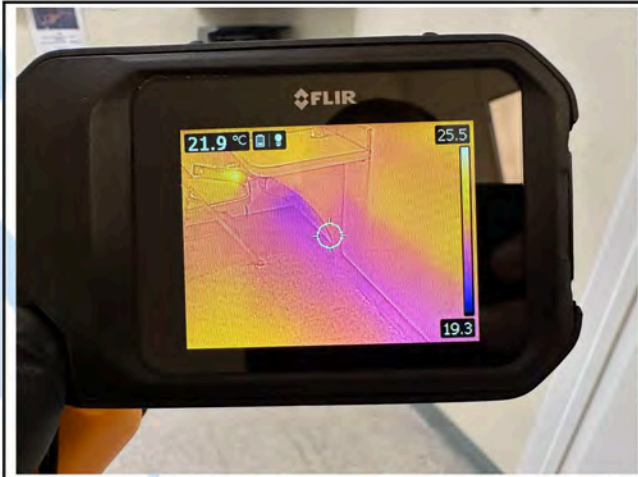
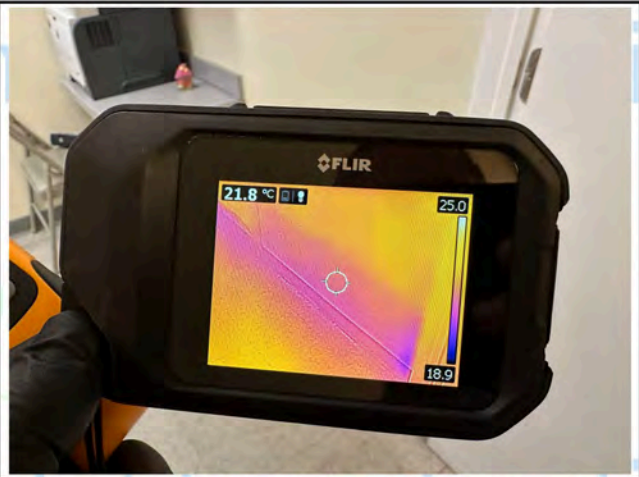
Office 4 - Thermal Imaging

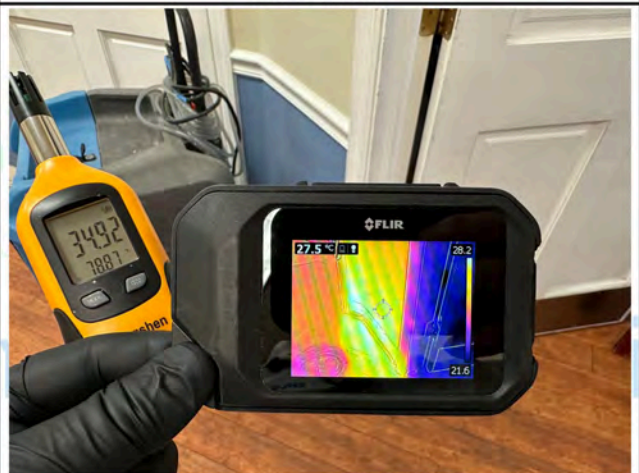
Main Hall 1 - Thermal Imaging

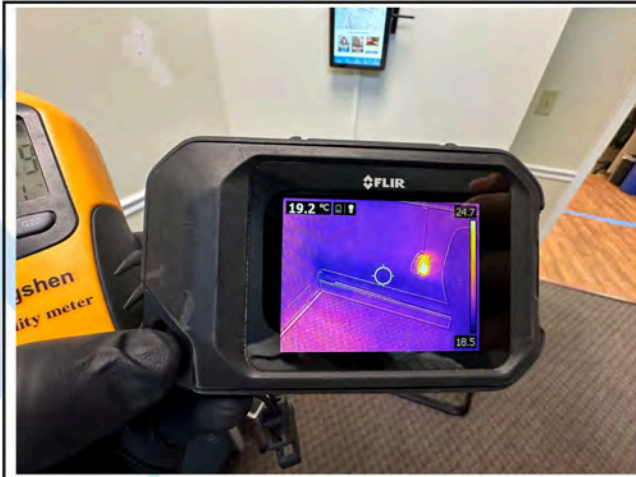
Room 1 - Visible Water Damage
