Pre Mitigation Impact Assessment

Inspection Performed For:
Commercial Medical Center

Inspection Performed At:
411 South Medical Ave
Any City, Florida 33333

Inspection Performed On:
April 30, 2024

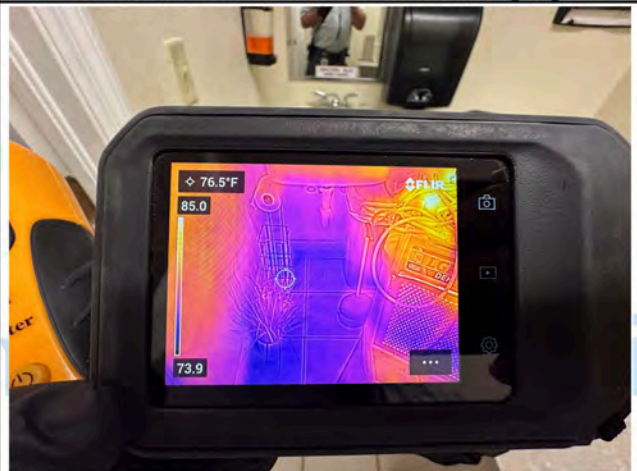
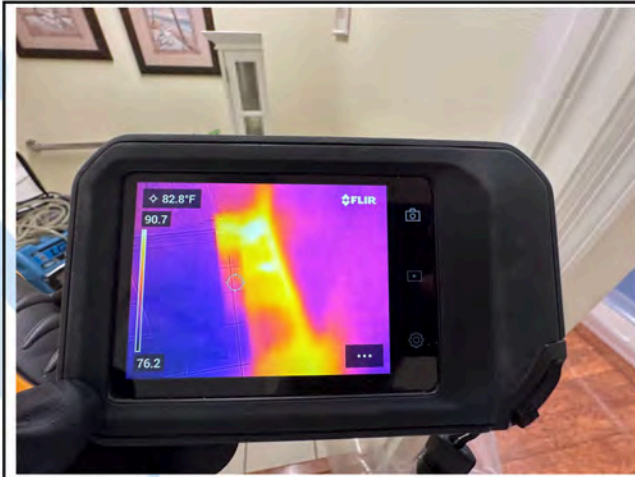
Employee Bathroom - Thermal Imaging
